SERVICE INSTRUCTIONS

*ET150 - ET200 (Same procedure for alarm equivalent models)

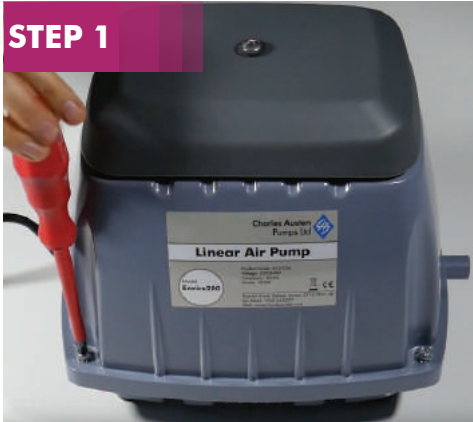
STEP 1

To start, unplug the pump from the mains. Unscrew and remove the cover from the air pump.

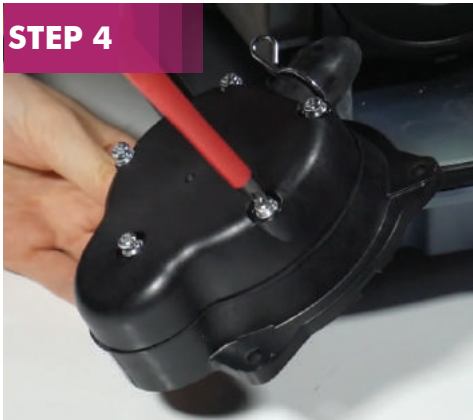
STEP 4

Unscrew the chamber block and pull it apart.

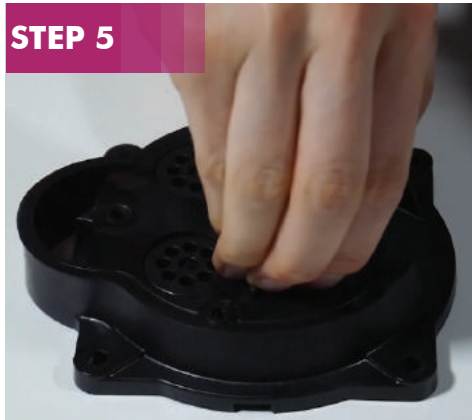
STEP 5

Remove the valves from the chamber block, take note of the valve formation.

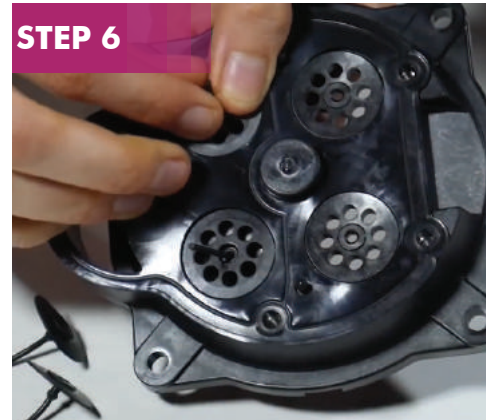
STEP 6

Pull the new valves through, you should hear a 'snap' sound once secured in place.

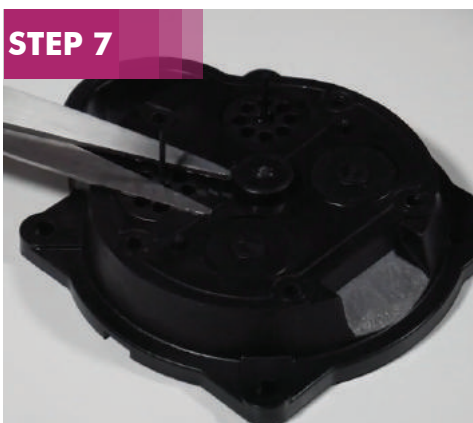
STEP 7

Cut the excess rubber off from the valves and discard.

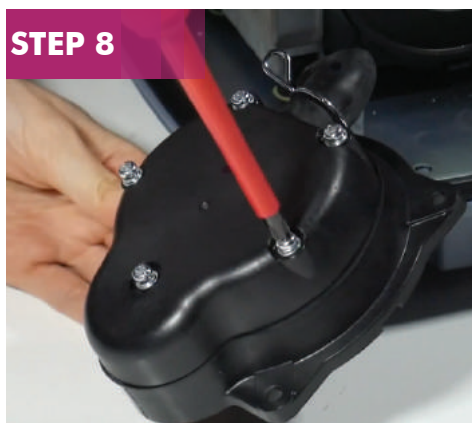
STEP 8

Screw the chamber block back together ensuring the rubber seal between them lined up properly. Repeat this process on the opposite side of the pump.

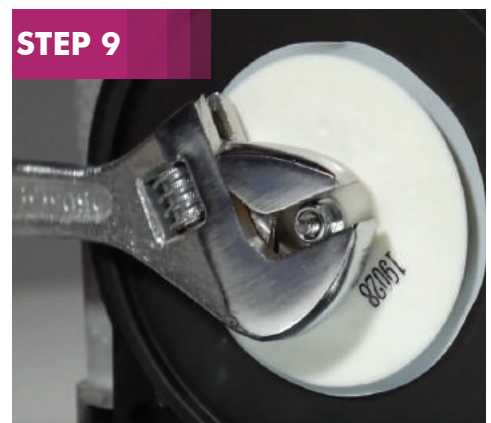
STEP 9

Undo the bolt from the diaphragm.

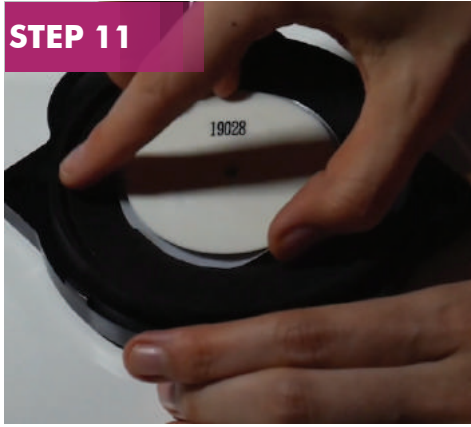
STEP 11

Replace the worn diaphragm with the new one provided in your service kit. Make sure the diaphragm has been pushed into the grooves of the diaphragm frame. Repeat this process on the opposite side of the pump.

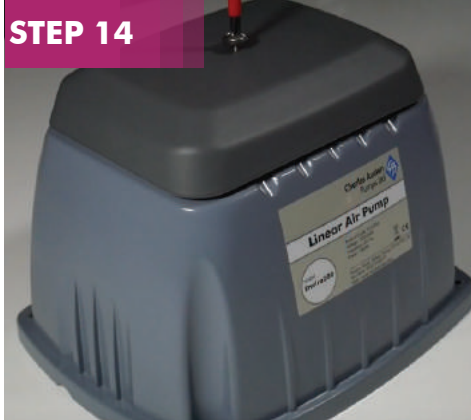
STEP 14

To change the filter unscrew the pump lid.

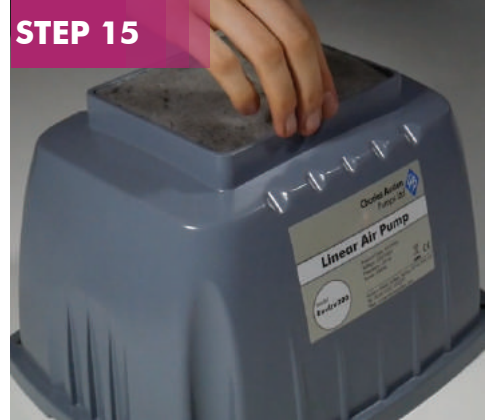
STEP 15

Remove the dirty filter and clean away any dust or dirt that has been collected.

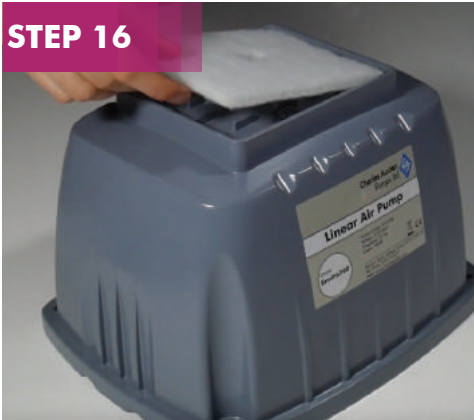
STEP 16

Replace the dirty filter with the new one provided in our service kit.

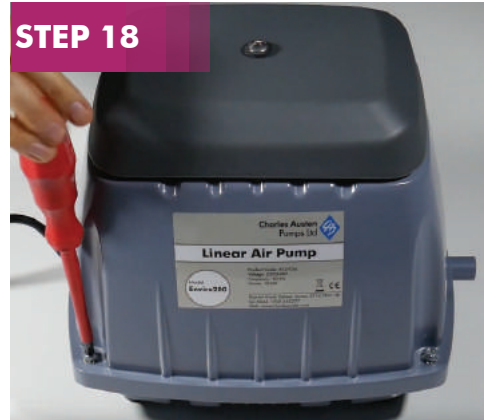
STEP 18

Finally, put housing back together ensuring the screws are secured down properly.
